# Manhole Inspection Summary

Manhole # S21KK1011MH

Insp Date: **11/9/06 10:48 AM**

**Location** Address: **4424 LAPLATA AVE**

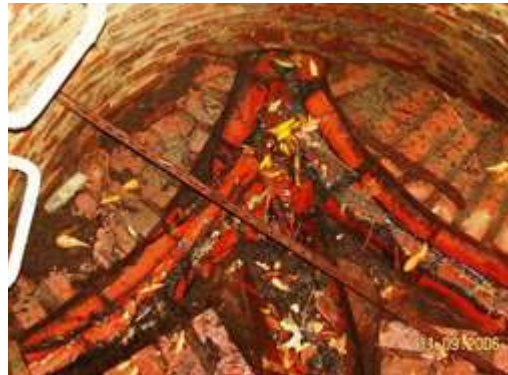
Top View

Bench and Channel debris.

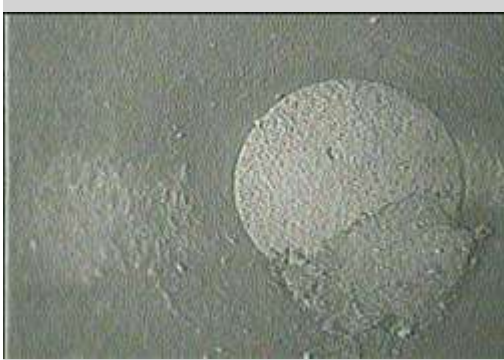
Inside the I6

Plugged.

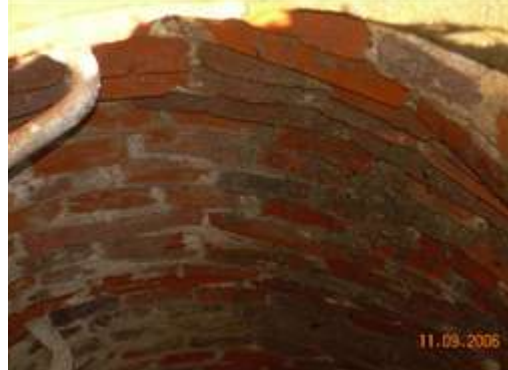
Defect

Frame leaks. Adjustment and Corbel infiltration.

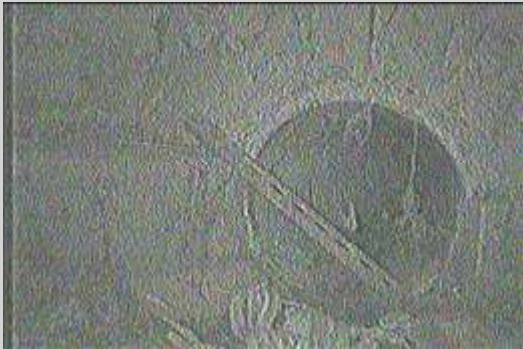
### 8 in. Circular Gravity Sewer Pipe Out @ 12 O'Clock

Infiltration: **None** Pipe Seal Cond: **Roots**

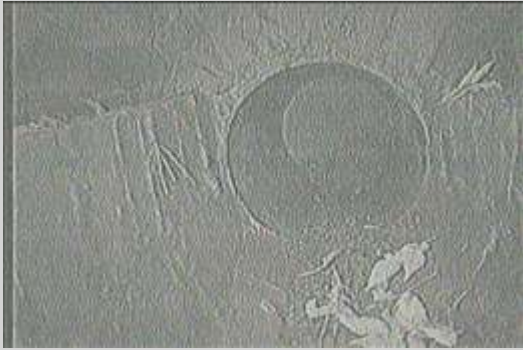
### 8 in. Circular Gravity Sewer

Infiltration: **None** Pipe Seal Cond: **Cracked**

Connects To: **Stub connection / abandoned**

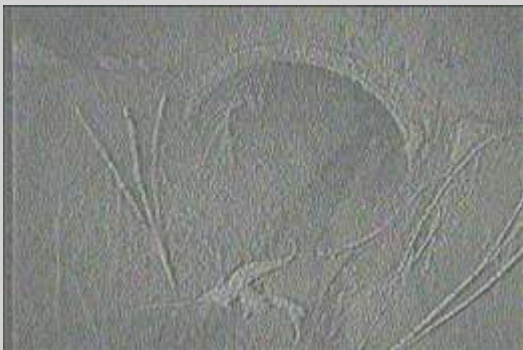
### 6 in. Circular Gravity Sewer

showing roots in channel

Infiltration: **None** Pipe Seal Cond: **Roots**
